iColor 550

Error Message listing

5. TROUBLESHOOTING

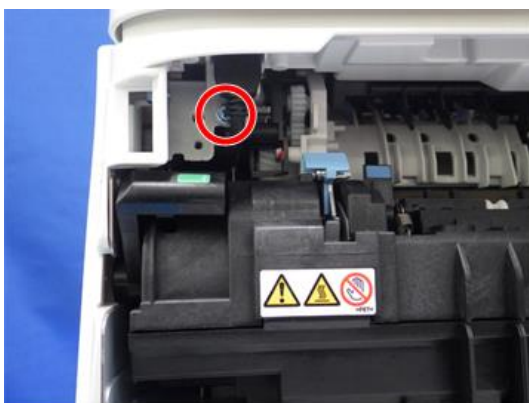
m0aga0082

- iColor 550: Check that the screw shown in the picture is fixed.

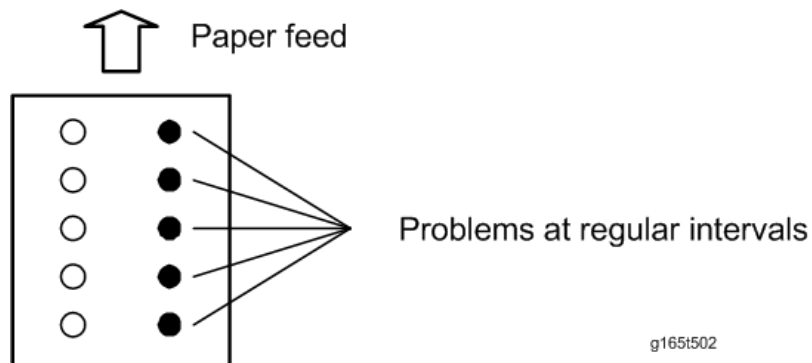
Image problems may appear at regular intervals that depend on circumstances of certain components. The following diagram shows the possible symptoms (black or white dots at regular intervals).

- Abnormal image at 24-mm intervals: Image transfer belt unit
- Colored spots at 38-mm intervals: AIO cartridge (Development roller)
- Abnormal image at 60-mm intervals: Transfer roller
- Colored spots at 75-mm intervals: AIO cartridge (OPC drum)
- Abnormal image at 110-mm intervals: Fusing unit (Pressure roller)
- Abnormal image at 141.3-mm intervals: Fusing unit (Fusing belt)

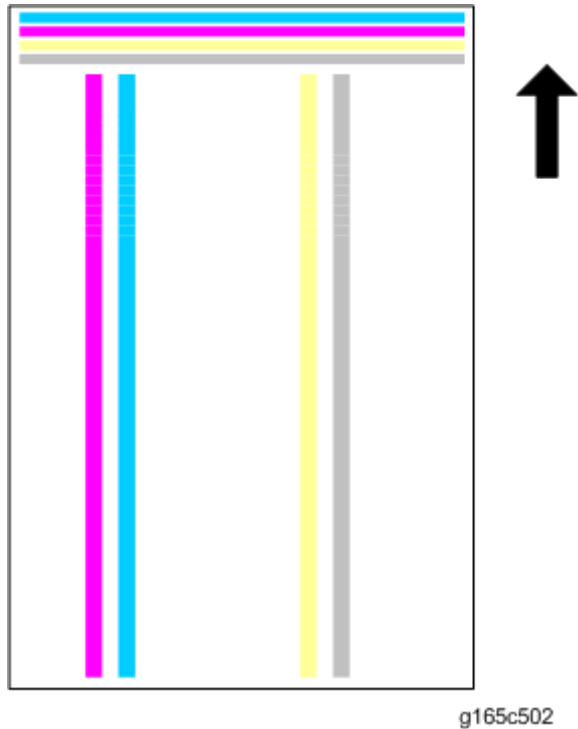
Print out a mono-color pattern (all K, C, M, or Y), which will clarify if the cause is a problem with one of the AIO cartridges, Image transfer belt, image transfer roller, or the fusing unit. A sample page is provided with the printer driver's CD. You can print the sample page from the printer driver's CD. Before printing, you have to adjust the printer driver settings to make the problem become obvious. For details about adjusting the settings, refer to "Printer Driver Setting for Printing a Sample" described below.

- Occurs with 1-3 colors: AIO cartridge(s) failure
- Occurs with all four colors: Image transfer belt, transfer roller or fusing unit failure

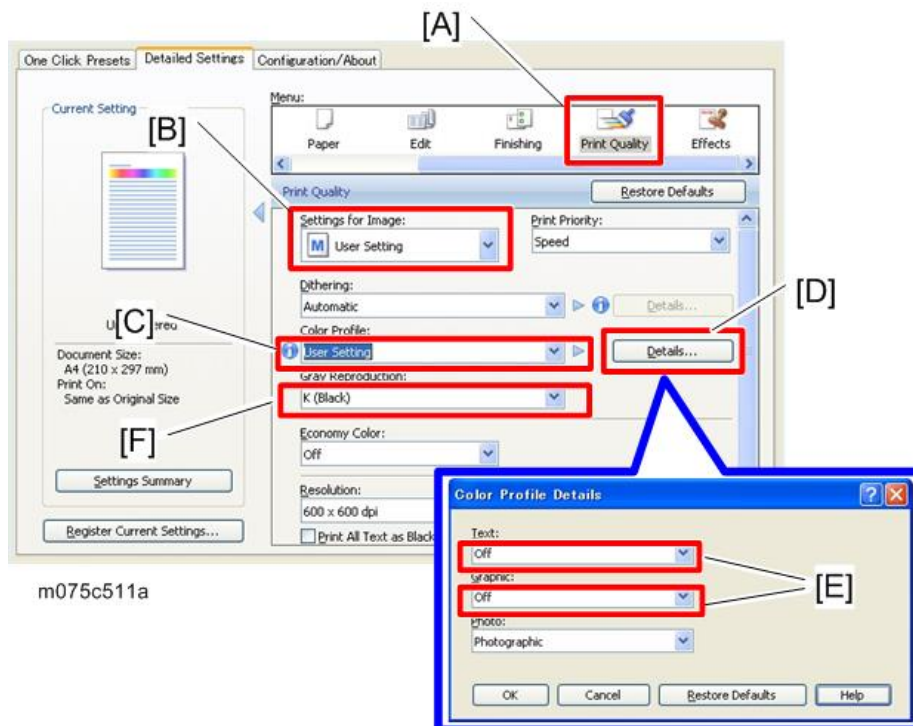
1. Click "Properties" on the printer driver.
2. Click "Printing Preferences" in the property screen.
3. Click "Detailed Settings" tab in the printing preferences screen.

4. Click "Print Quality" [A] in the Menu.
5. Select "User Setting" from the pull-down menu in the "Settings for Image" [B].

6. Select "User Setting" from the pull-down menu in the "Color Profile" [C].
7. Press "Details..." [D], and then select "Off" from the pull-down menus [E] in the "Text:" and "Graphic".
8. Select "K (Black)" from the pull-down menu in the "Gray Reproduction" [F].
